Subject: Boeing Submission - Egyptair 767-300ER SU-GAP, Accident off

Nantucket, Massachusetts - 31 October 1999

# Submission to the National Transportation Safety Board for the

# Egyptair 990 Investigation

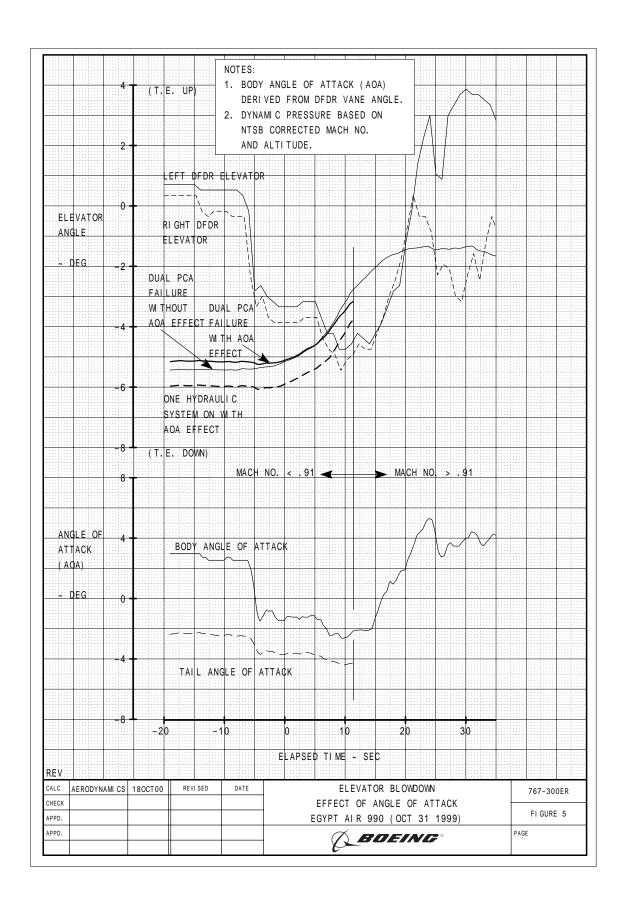
of the maximum force with one hydraulic system operating. They are plotted versus elapsed time on figure 5 (page A-13). The actual elevator angles recorded by the DFDR are also shown, along with the body and tail angles of attack that were used in this analysis. The elevator blowdown angles based upon hinge moment coefficients that do not account for angle of attack are also presented for the dual PCA failure. They are presented for the entire DFDR time interval because the original elevator hinge moments were extended beyond a Mach number of 0.91. These Mach extended hinge moments and blowdown angles are the data that were used in the March 2000 simulator evaluations of dual PCA failures. These simulations are described in this appendix in the *Dual Elevator PCA Failure Simulation* section.

This analysis shows that the effects of angle of attack on elevator hinge moment and blowdown angle are quite small (as much as 0.3 degrees of elevator blowdown angle for a portion of the dive). This minimal effect justifies the level and shape of the elevator blowdown data used in the March 2000 evaluations of hypothetical dual PCA failures. It also supports the exclusion of angle of attack as a variable during the original formulation of elevator hinge moment coefficients.
